ANNUAL SUMMARY REPORT (May 1, 1967, through April 30, 1968)

THE EFFECT OF COMPOSITION ON THE MECHANISM OF STRESS-CORROSION CRACKING OF TITANIUM ALLOYS IN N<sub>2</sub>O<sub>4</sub>, AND AQUEOUS AND HOT-SALT ENVIRONMENTS

NATIONAL AERONAUTICS AND SPACE ADMINISTRATION Contract No. NASr-100(09)

J. D. Boyd, F. H. Haynie, P. J. Moreland, W. K. Boyd, R. A. Wood, D. N. Williams, and R. I. Jaffee

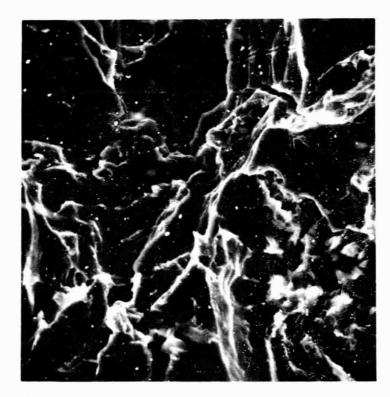
FIGURE 2. SCANNING ELECTRON MICROGRAPH OF A SALT-WATER STRESS-CORROSION FRACTURE IN Ti-8Al-1Mo-1V

Titanium alloys fail at low stress intensities in aqueous environments because cleavage microcracks are nucleated in the vicinity of the main crack (Figures 2 and 4). The cracking mechanism is the sequence that leads to the nucleation of cleavage cracks in material that would otherwise fracture in a ductile manner.

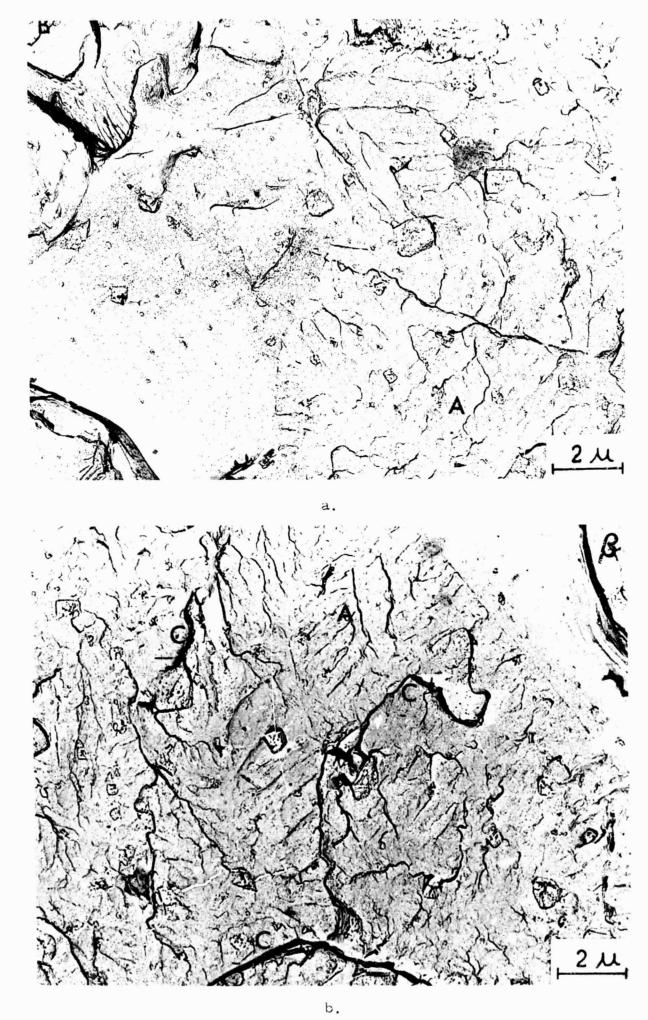
FIGURE 4. ELECTRON-REPLICA MICROGRAPHS OF A SALT-WATER STRESS-CORROSION FRACTURE IN Ti-8Al-1Mo-1V

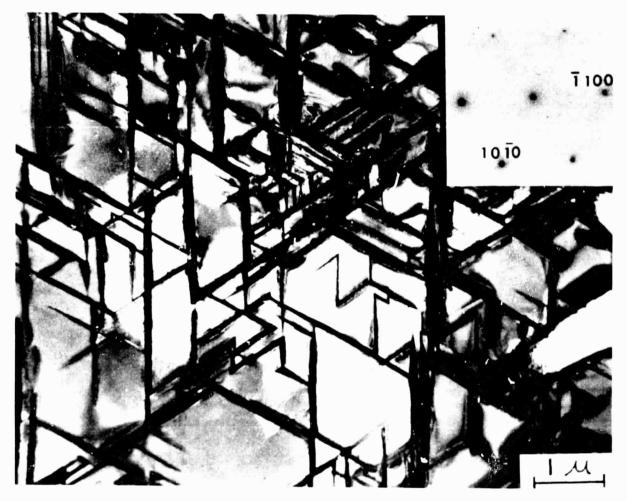
FIGURE 9. SPECIMEN CHARGED WITH 800 PPM HYDROGEN, SHOWING SPONTANEOUSLY NUCLEATED HYDRIDES

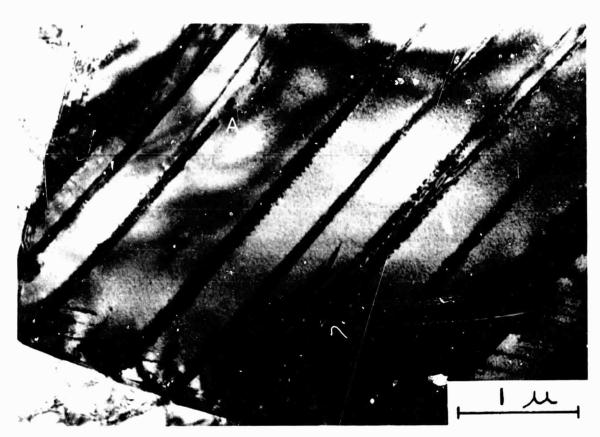
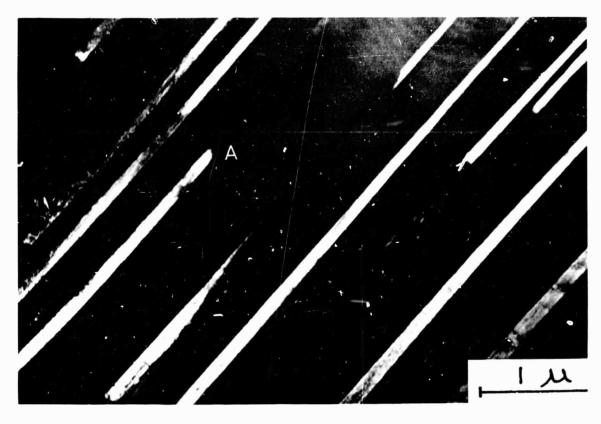
a. Strain-Induced Hydrides Lying in  $(10\overline{1}0)$  Slip Planes

b. Same Area as Above; Dark-Field Micrograph From Hydride Reflection FIGURE 10. Ti-8Al-1Mo-1V, CHARGED TO 400 ppm HYDROGEN AND DEFORMED 3 PERCENT

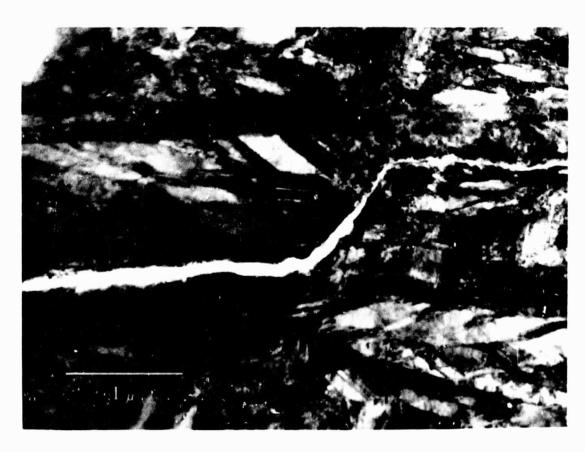
FIGURE 12. Ti-6A1-4V, STA, STRESSED IN RED N<sub>2</sub>O<sub>4</sub>, SHOWING CRACK RUNNING PARALLEL TO MARTENSITE INTERFACES

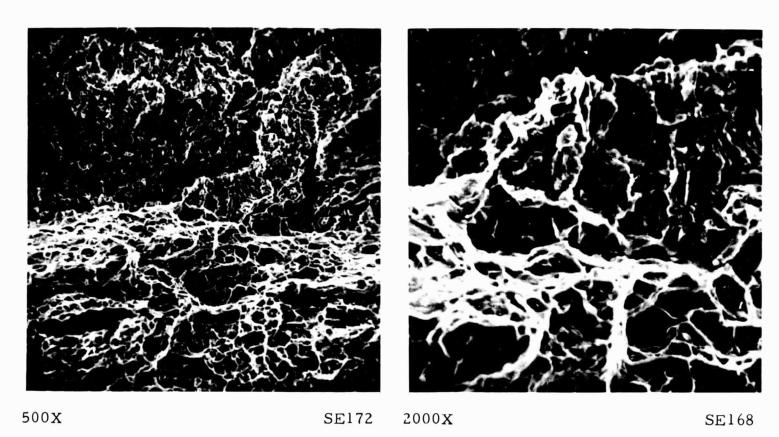
FIGURE 13. SCANNING-ELECTRON MICROGRAPHS OF N<sub>2</sub>O<sub>4</sub> STRESS-CORROSION FRACTURE IN "ANNEALED" Ti-6Al-4V, SHOWING BRITTLE AND DUCTILE REGIONS

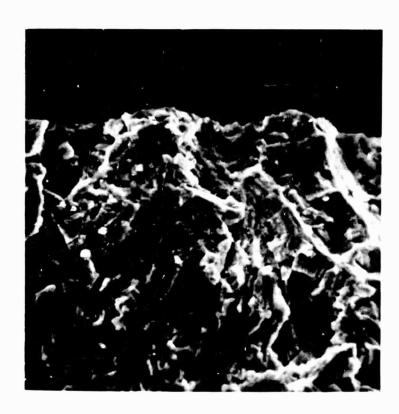
FIGURE 14. SCANNING-ELECTRON MICROGRAPHS OF  $\rm N_2O_4$  STRESS-CORROSION FRACTURE IN Ti-6Al-4V, SHOWING THE INITIATING EDGE

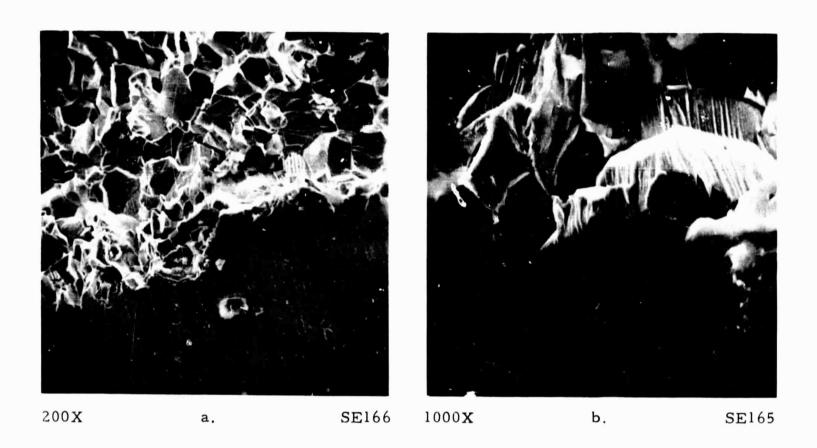
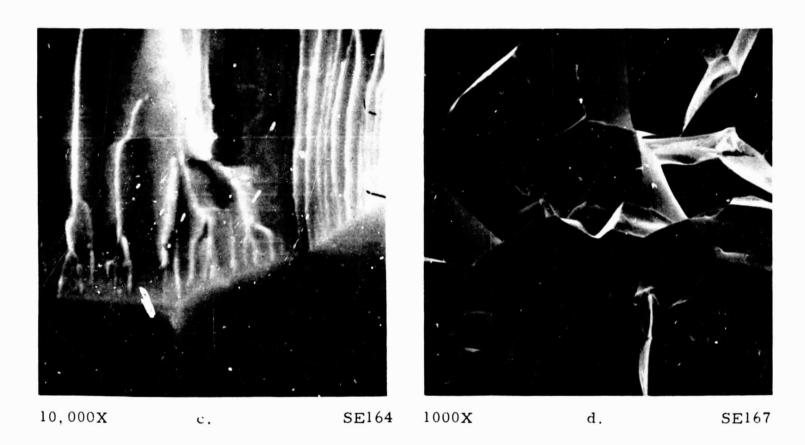
The Ti-8Al and Ti-4Al alloys were selected as representative of two distinct types of cracking behavior, and fractured specimens of each alloy were examined by scanning-electron microscopy. Figure 15 shows the mixed fracture modes that have occurred in the Ti-8Al. Both transgranular fast fracture and intergranular attack have occurred. Figures 15a, 15b, and 15c are micrographs of the initiating edge of the fracture surface in this constant-deflection bent-beam specimen. It appears that the initial attack is intergranular and that fast transgranular fracture occurs when a critical stress intensity is reached at the root of the slowly growing intergranular crack. The river patterns in Figure 15c are characteristic of mechanical transgranular fracture. Two factors that could contribute to this initiation of fast fracture are: (1) the growth of the intergranular crack increases the stress-intensity factor and (2) the environment embrittles the metal at the crack tip, thus lowering the critical stress-intensity factor. Absorption of corrosion-produced hydrogen into the highly strained metal at the crack root could produce embrittlement. It would not be necessary to embrittle more than a small

FIGURE 15. SCANNING-ELECTRON MICROGRAPHS OF METHANOL STRESS-CORROSION FRACTURES IN Ti-8Al
